RE: CRITICAL BRIDGE DEFICIENCY

Webster Bridge #066/113 - White Plains Road over Meadow Brook

Bridge Inspection Report

Webster 066/113

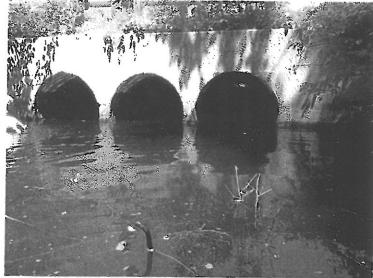
X018 04

DOWNSTREAM ELEVATION. NOTE DEBRIS BLOCKAGE OF BARREL (TYPICAL OF ALL THREE PIPES).

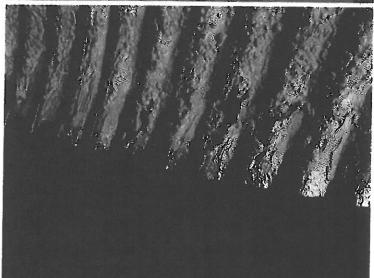
X018 05

TYPICAL HEAVY RUSY AND SECTION LOSSES ON PIPE WALL.

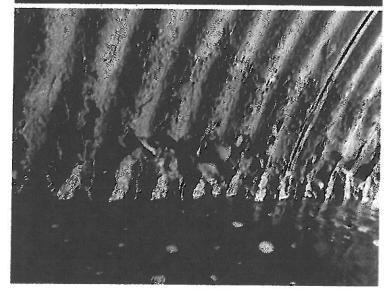
X018 06

^L 1000	Corrosion	MINOR TO LIGHT SCALE AND RUST IN PIPE #2. PIPE #1- 10' FROM SOUTH END, HOLED IN A 6' SECTION WITH UP TO 90% SECTION LOSS; 17' FROM SOUTH END, HOLED THROUGH IN A 1' AREA, 100% SECTION LOSS. PIPE #3- HOLED THROUGH IN A 8 in. AREA WITH FILL EXPOSED, MIDSPAN. ALL THREE PIPES HOLED AT INLET INVERT AND SIDES FROM RUST AND DAMAGE.
^L 1020	Connection	UPSTREAM JOINTS SEPARATED UP TO 2.5 in
^L 1900	Distortion	SAGS IN ROFFLINE OF PIPE # 1.
[[] 6000	Scour	DEBRIS IN PIPES # 2 & 3, MIDSPAN.
L7000	Damage	INLET ENDS (NORTH) OF ALL THREE PIPES HAVE DAMAGE CAUSED BY BEAVER DAM REMOVAL.

TYPICAL HEAVY RUSY AND SECTION LOSSES ON PIPE WALL. NOTE GRAVEL FILL EXPOSED.

This deterioration has reduced the safe calculated live load capacity, resulting in a required posting of "WEIGHT LIMIT 3 TONS" and "PASSENGER CARS ONLY" for the short-term. However, without action, this bridge will likely require a closure in the near future. The municipality should monitor this structure closely for signs of further deterioration. Due to the extensive nature of the deterioration, slip-lining or complete replacement may be the only viable remedial actions.
